## ADDENDUM NO. 2 (TWO)

**DATE:** September 11, 2026  
**PROJECT:** SE881 - Life Science - Integrated Learning Classroom Renovation  
**OWNER:** The Trustees of Indiana University  
**IU PROJECT NO.:** 20251009

To: Somsri Bond  
From: Kevin Ooley  
Subject: SE 881 Life Science - CPF#20251009 - EHS# 7267  
Date: 3/9/2026

Scope: Perform visual inspection to provide information on the amount and condition of any possible Asbestos Containing Materials (ACM) at IU Southeast Campus – SE 881 Life Sciences- rooms 232,234,236,238, and 240

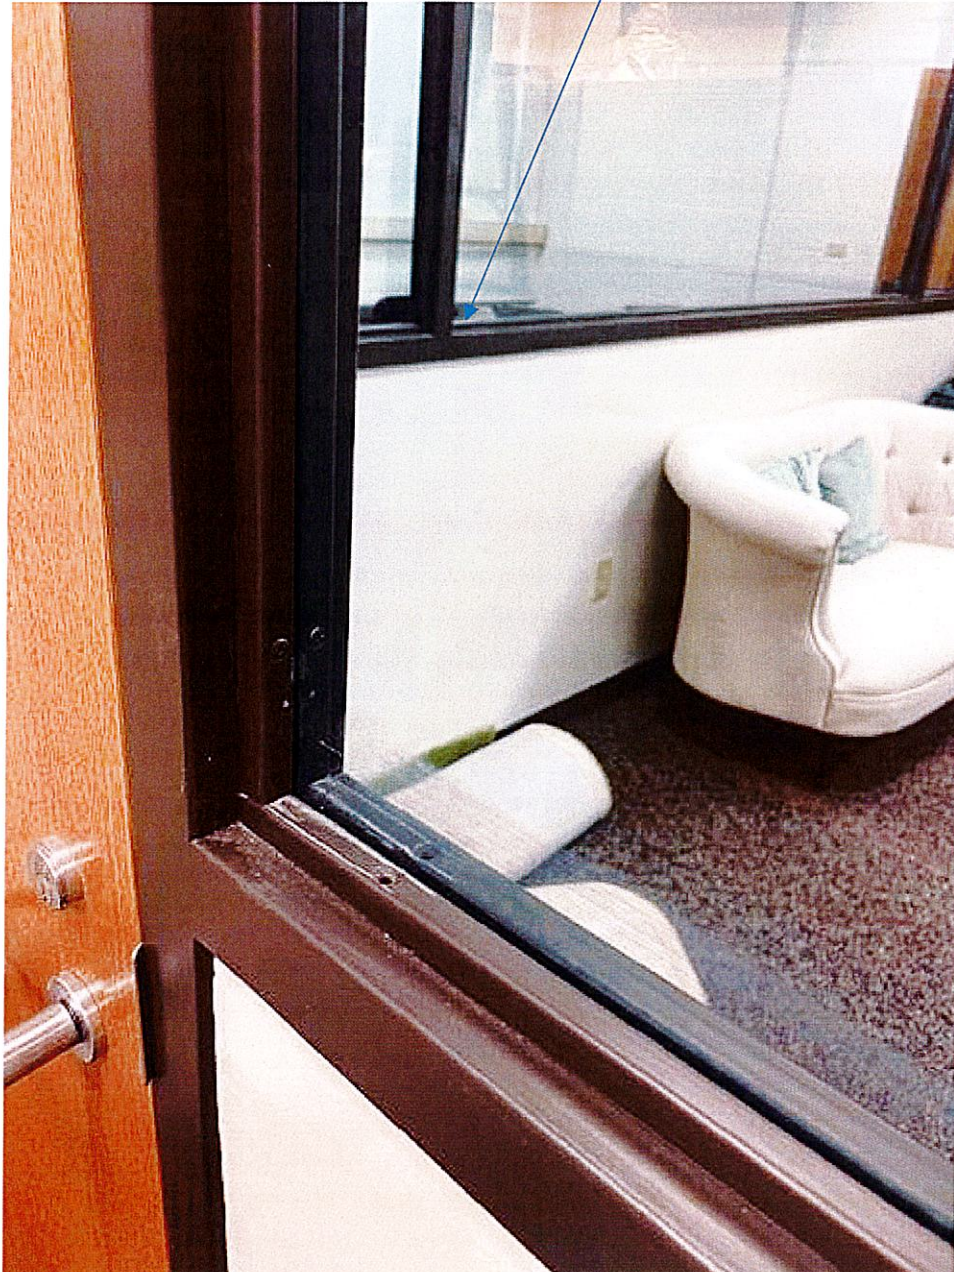
Rooms 234 and 236- Interior  
windows no ACM material  
found

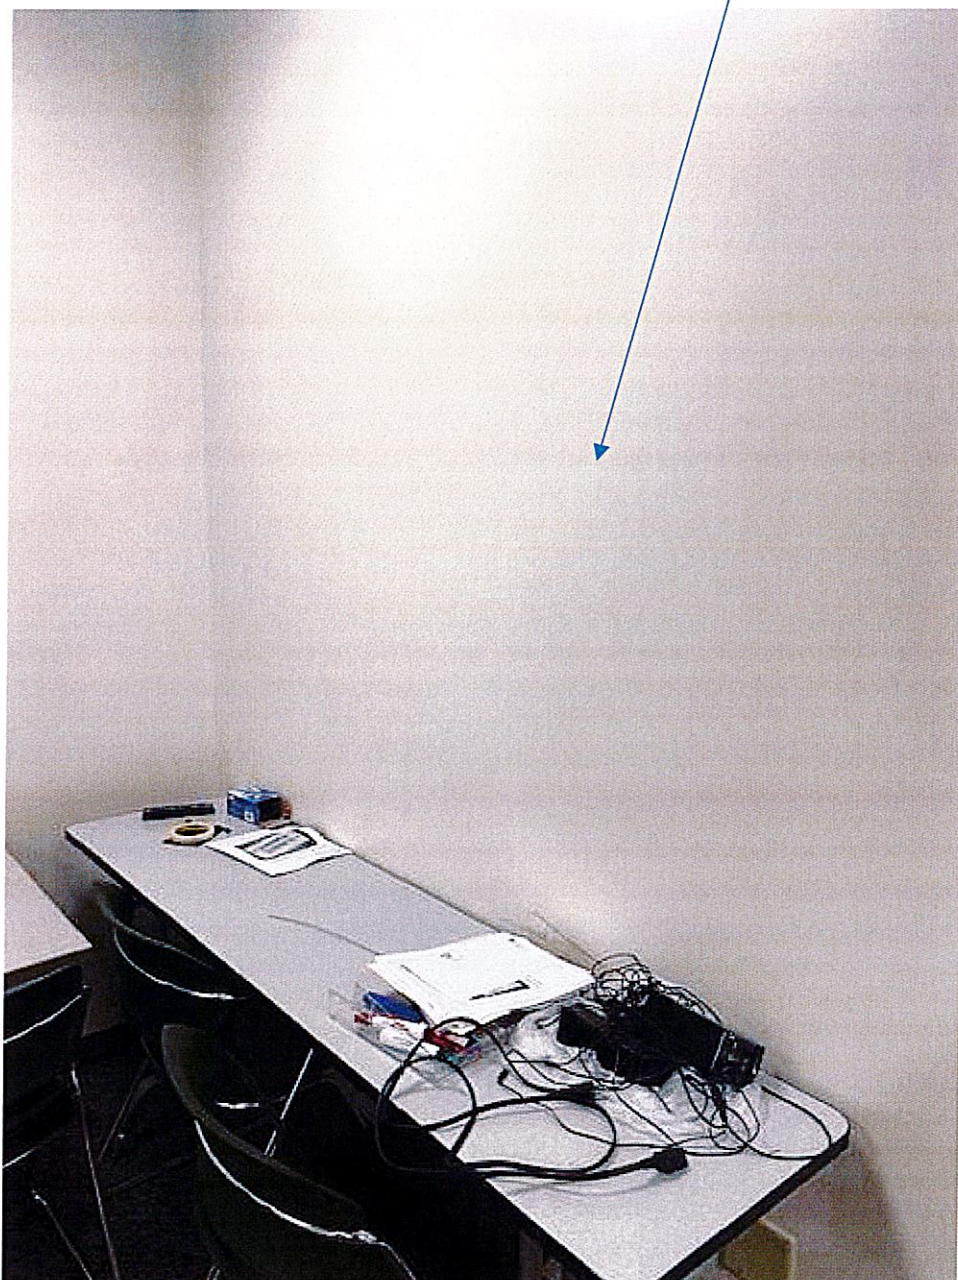
Rooms 232,234,236,238,240 –  
all dry wall is non-ACM

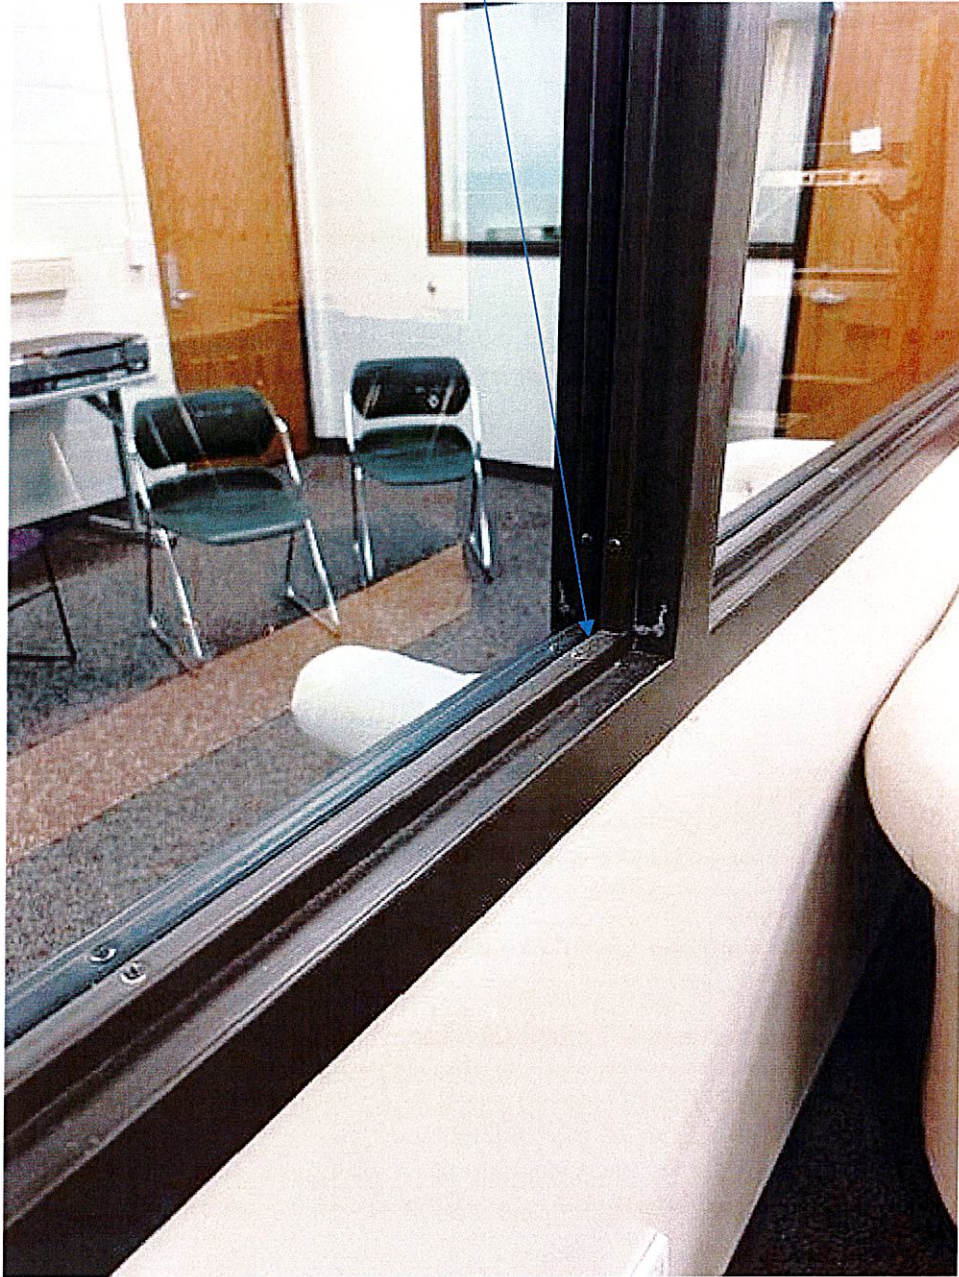
Rooms 234 and 236- Interior  
windows no ACM material  
found

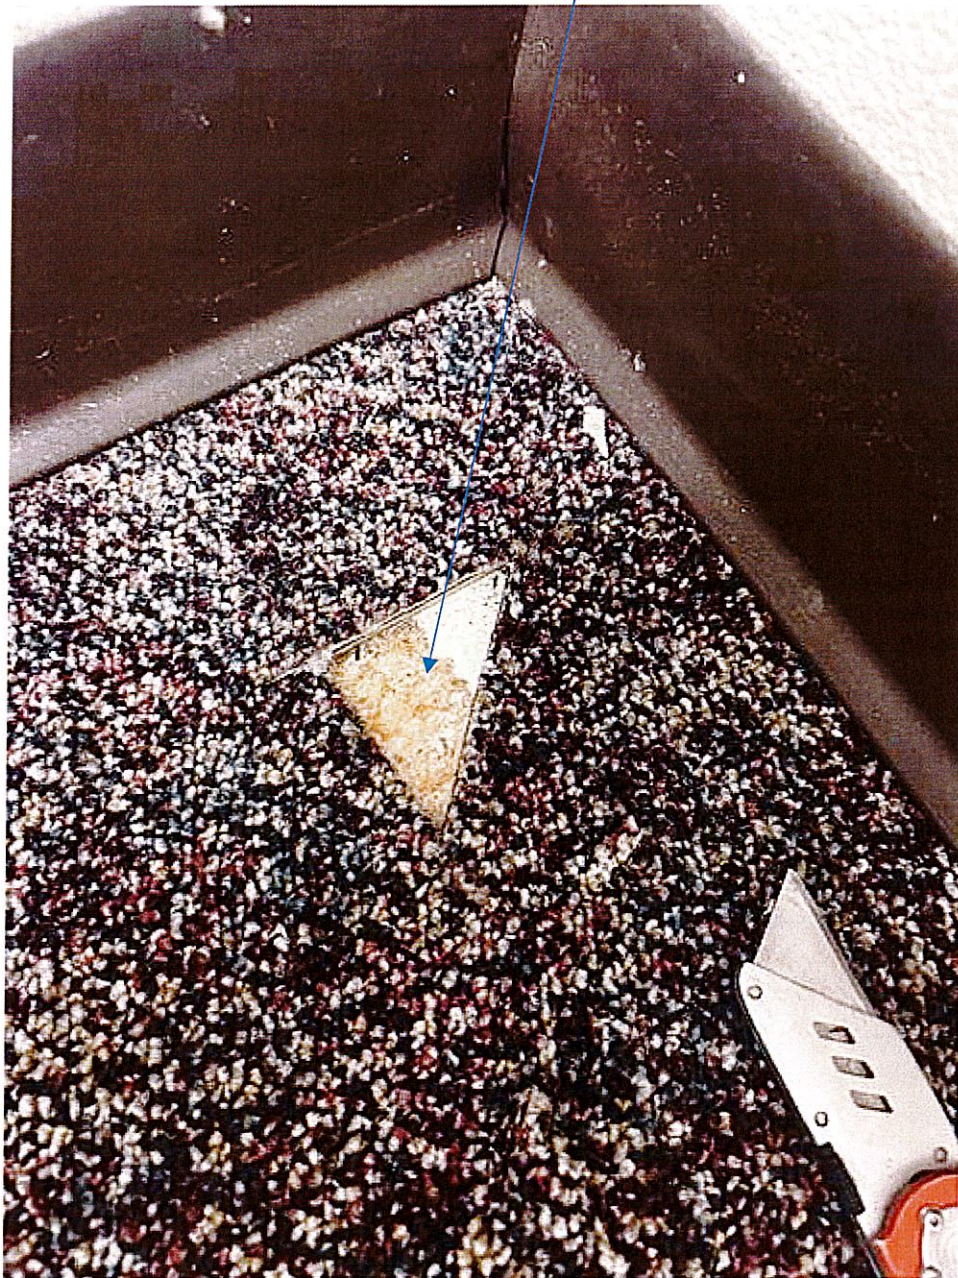
Rooms 234,236,232, and 240-  
all clear carpet mastic is non-  
Acm

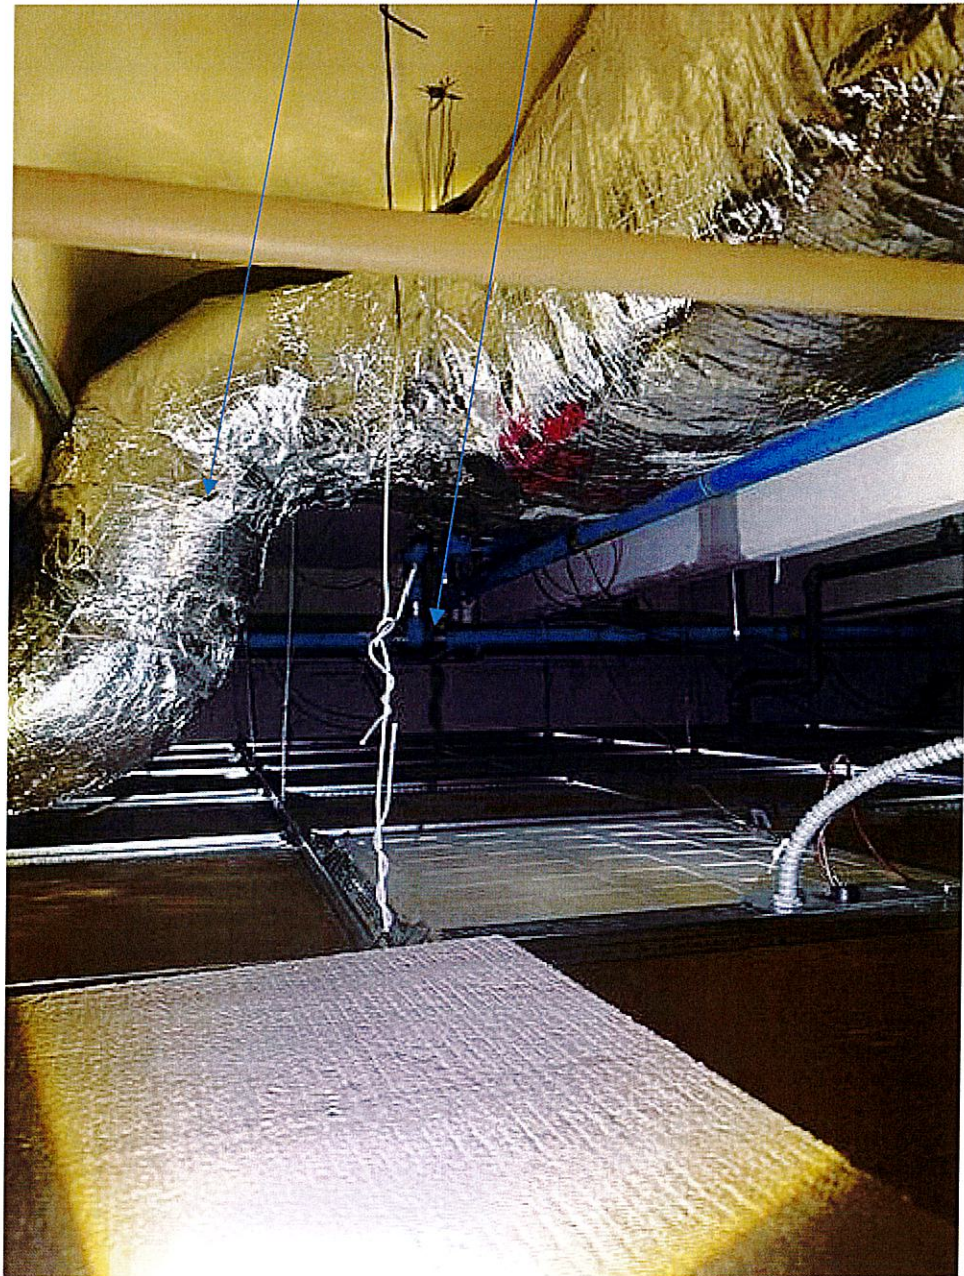
Room 232,234,236,238, and  
240 no ACM suspect material  
was found above the ceilings

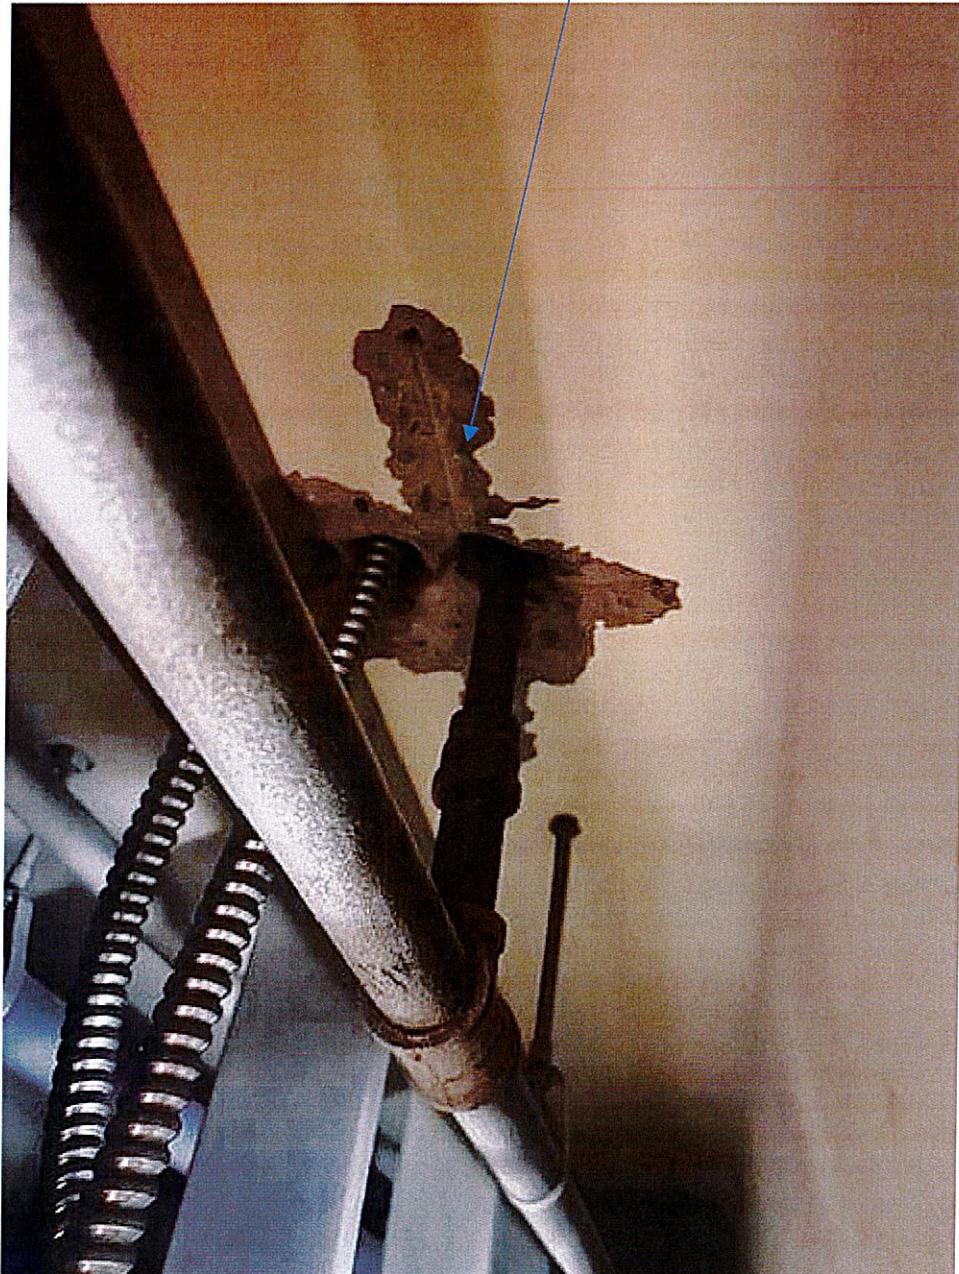
Rooms 232,234,236,240 No  
plaster ceiling found – concrete  
deck with white paint -

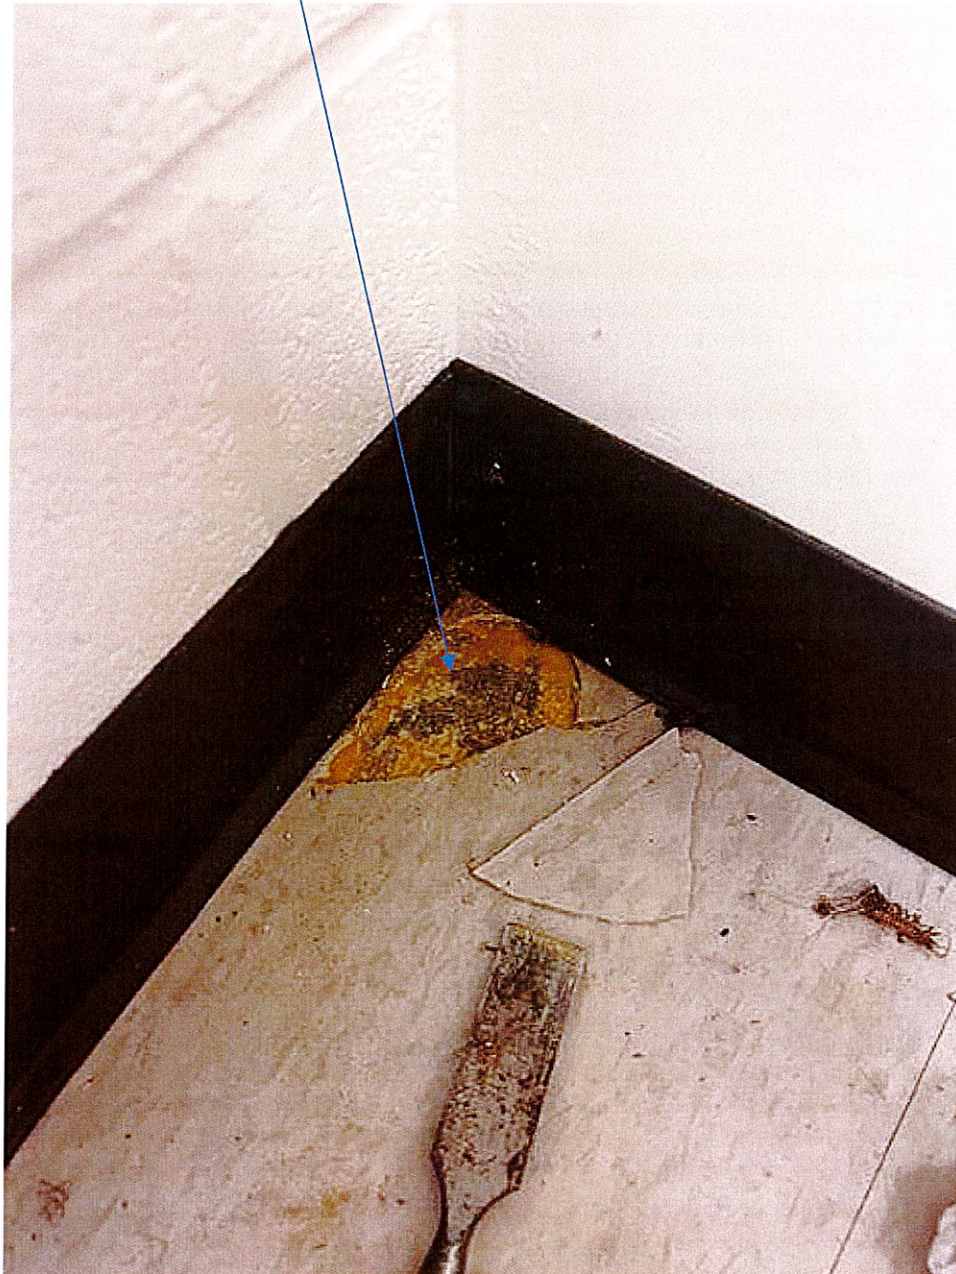
| LABORATORY ANALYSIS: | | | SAMPLE TYPE: | | | |
|---|---|---|---|---|---|---|
| 7267-14 14 | Room 238- white 12"x12" floor tile with yellow mastic | 03/05/26 | HA-5 | | ND/ND | |
| 7267-15 14 | Room 238- white 12"x12" floor tile with yellow mastic | 03/05/26 | HA-5 | 8260663 | ND/ND | |

Room 238 – white 12x12 floor  
tile with yellow mastic- non-  
Acm

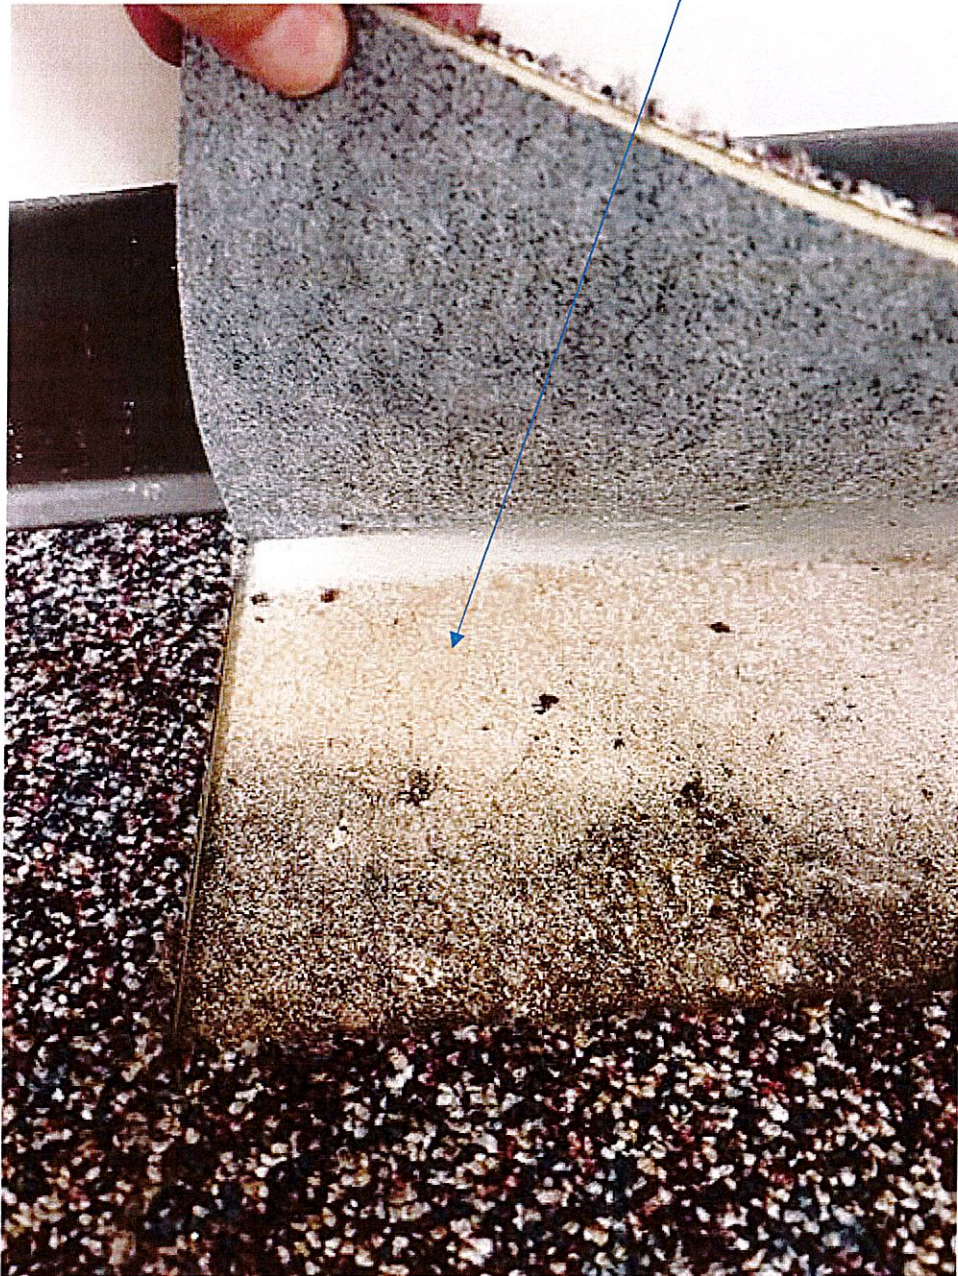
Rooms 234,232,236,240- all  
clear mastic under carpets –  
non- ACM

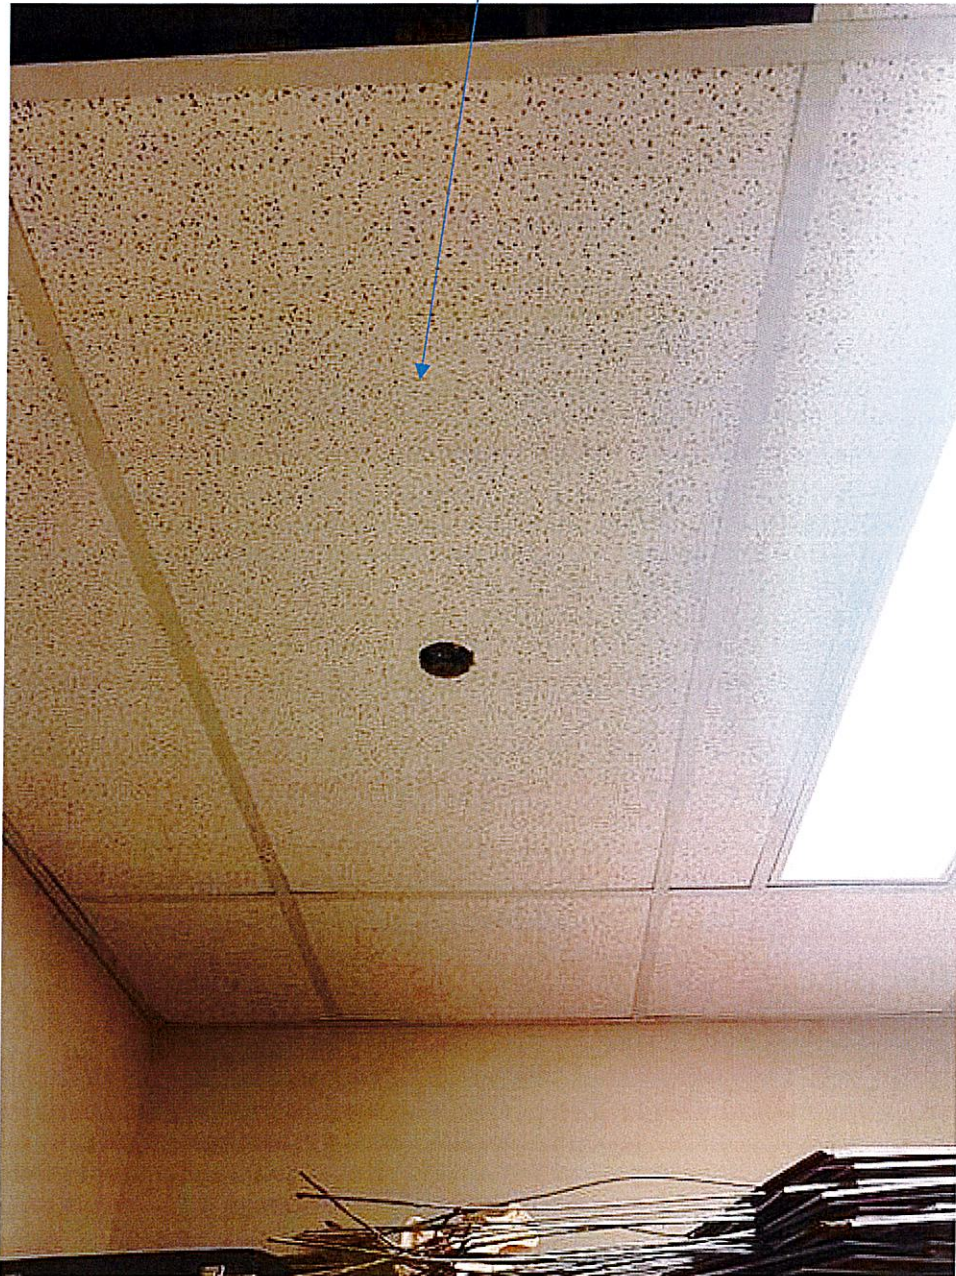
| LABORATORY ANALYSIS: | | SAMPLE TYPE: | | Homogenous Area | Lab I.D.: | RESULTS: |
|---|---|---|---|---|---|---|
| 7267 -7 | Rooms 238- 2x4 lay in ceiling tiles - pins | 03/05/26 | | HA-3 | | NV |

Room 238 – 2x4 ceiling tile –  
pins – non-Acm

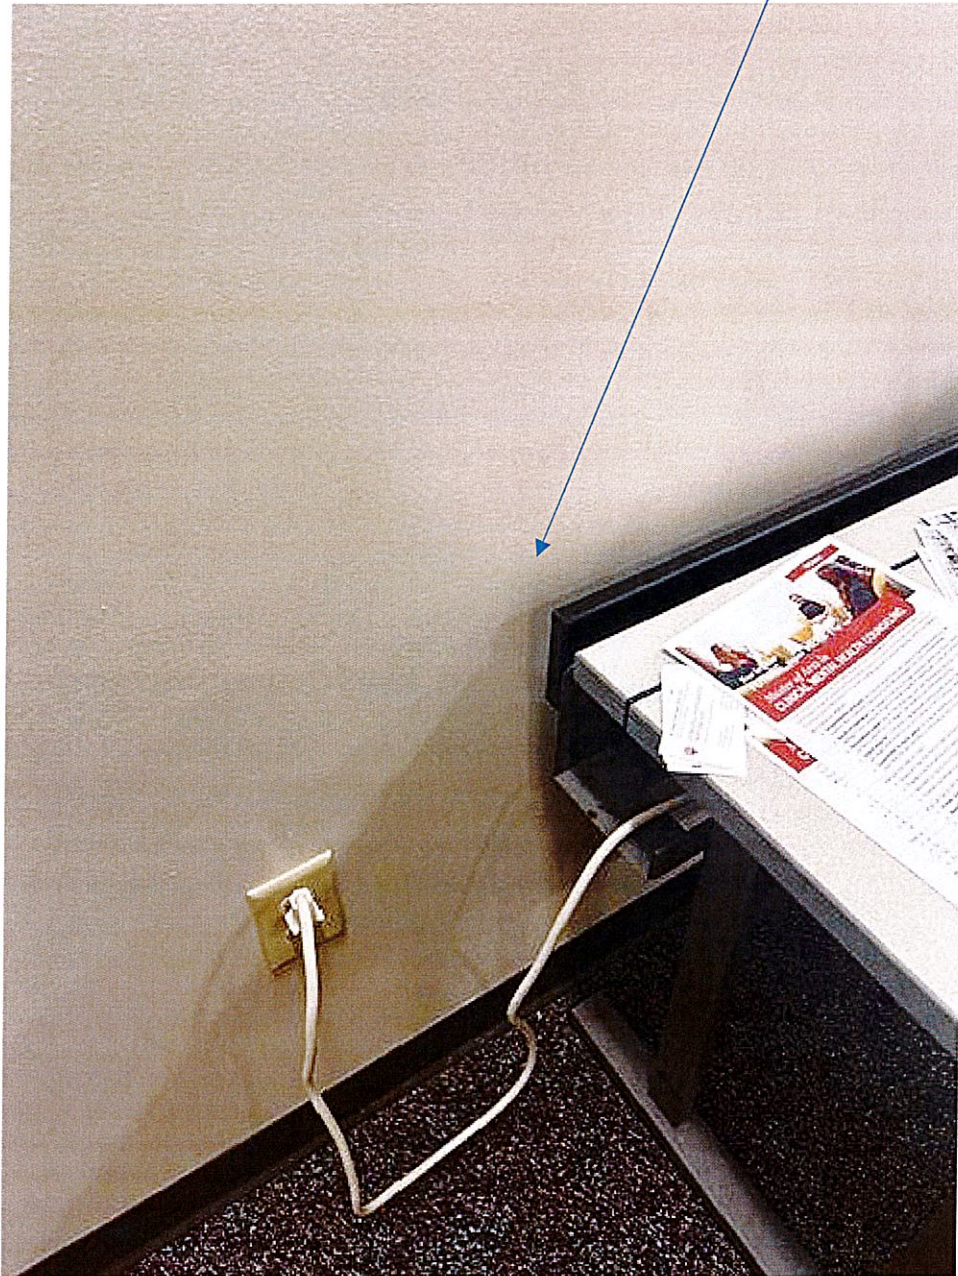
Rooms 232,234,236,238, 240 -  
dry wall - non-ACM

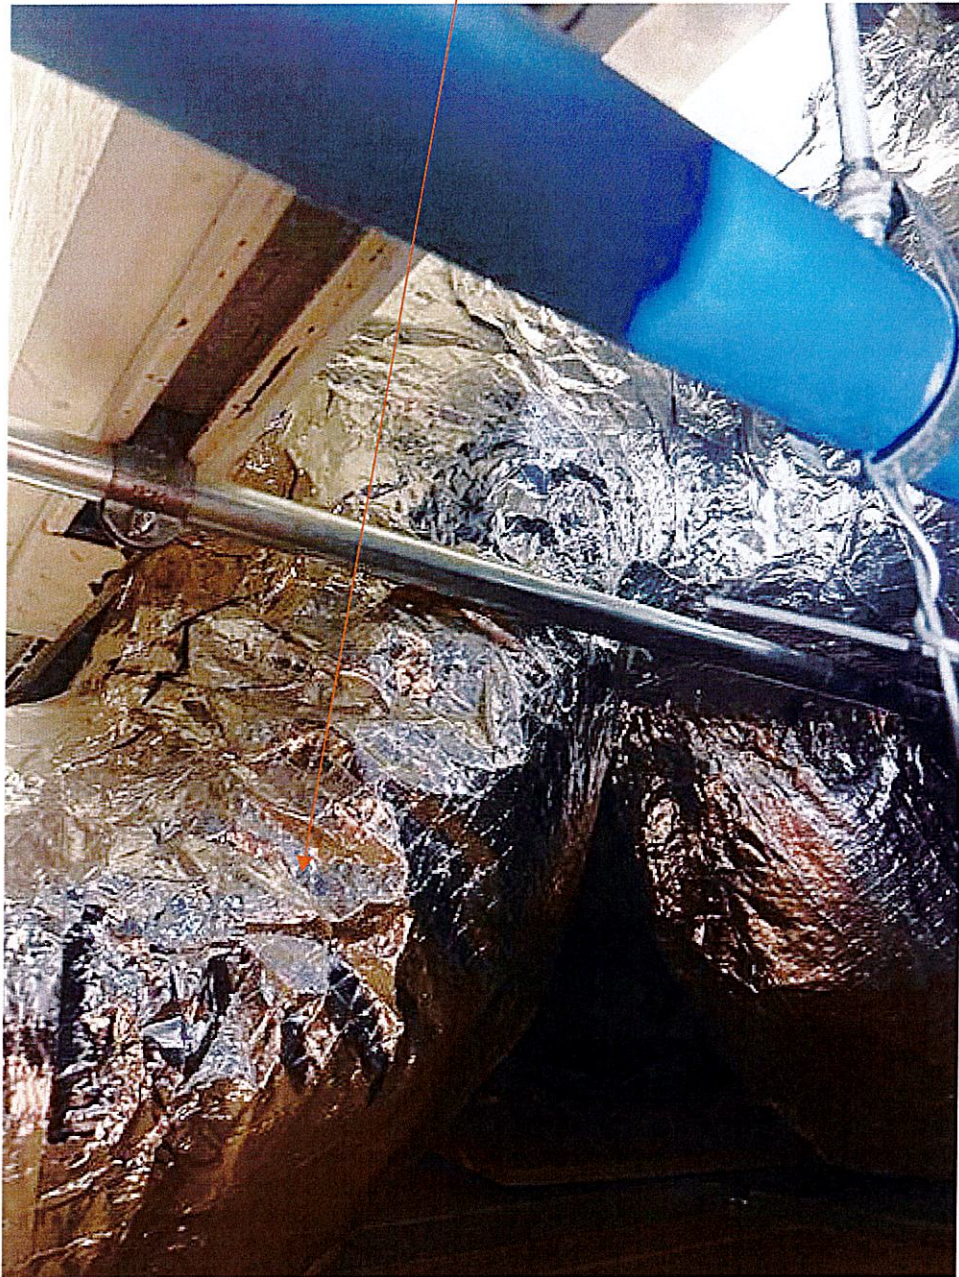
All duct work – non-ACM

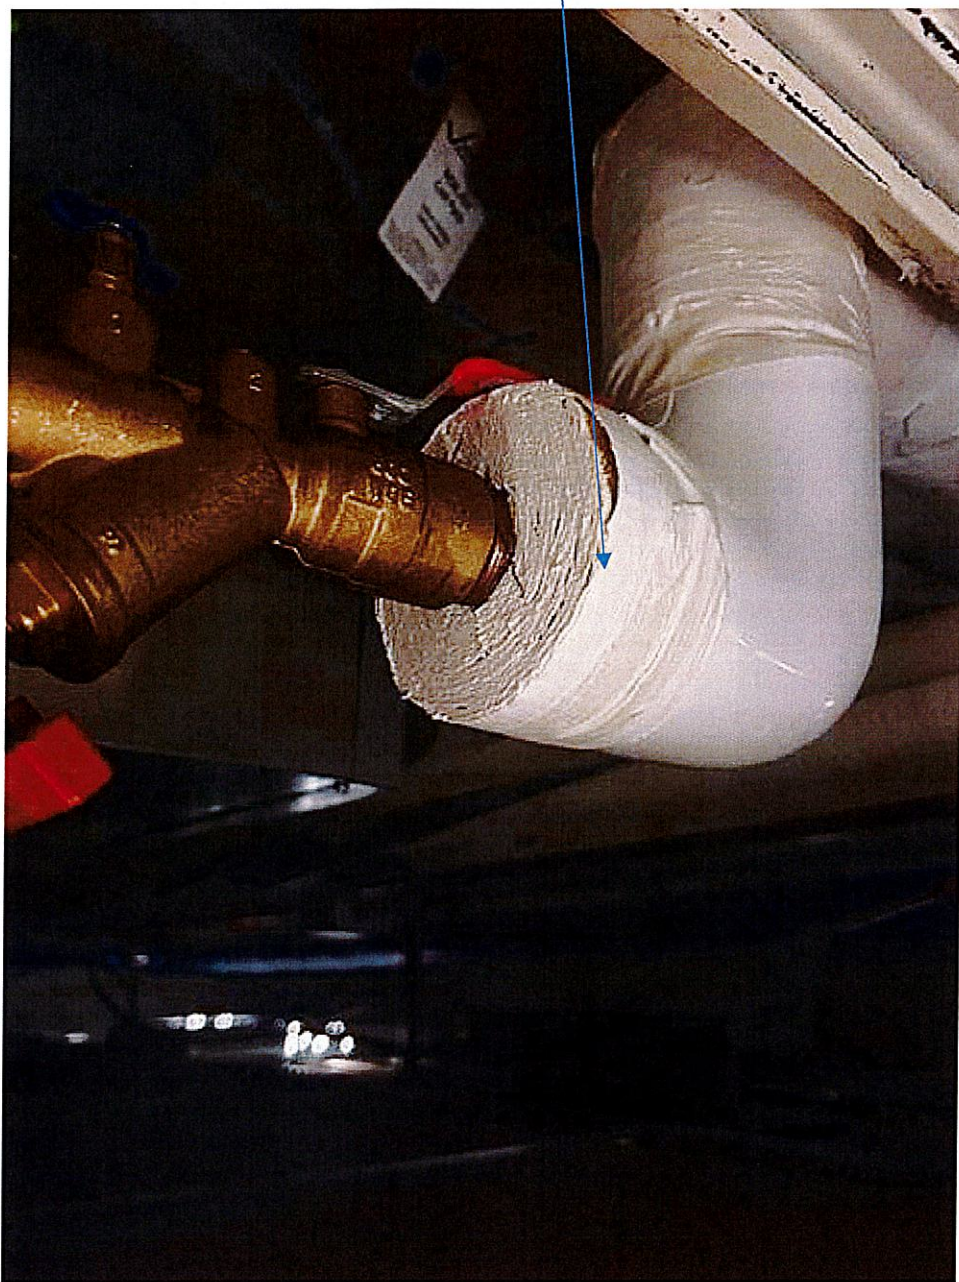
All pipe insulation above  
ceilings is fiberglass insulation –  
non AcM

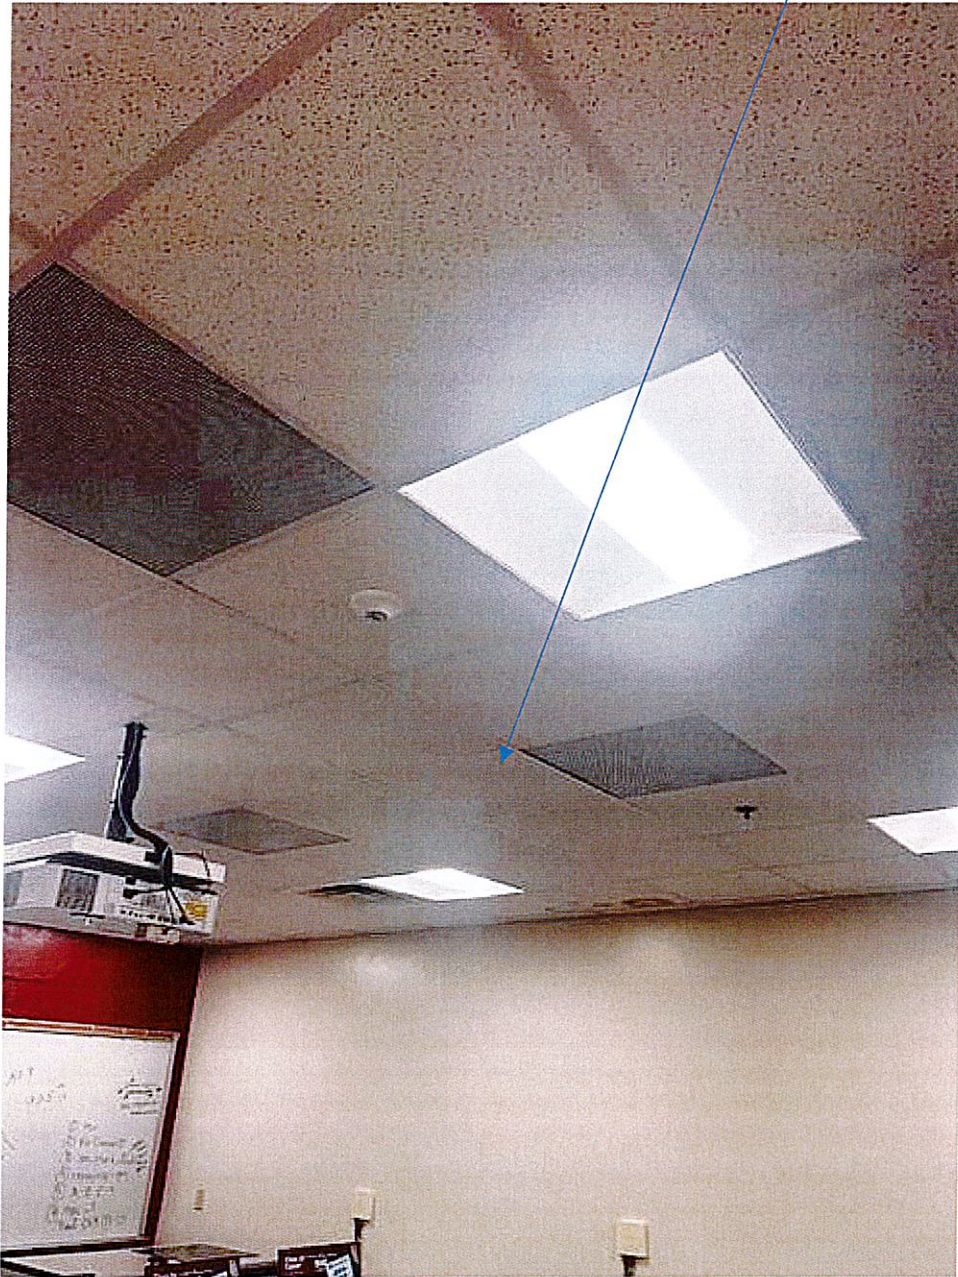
Rooms 232,234,236,238,240 =  
2x2 lay in ceiling tiles- pins –  
non-Acm

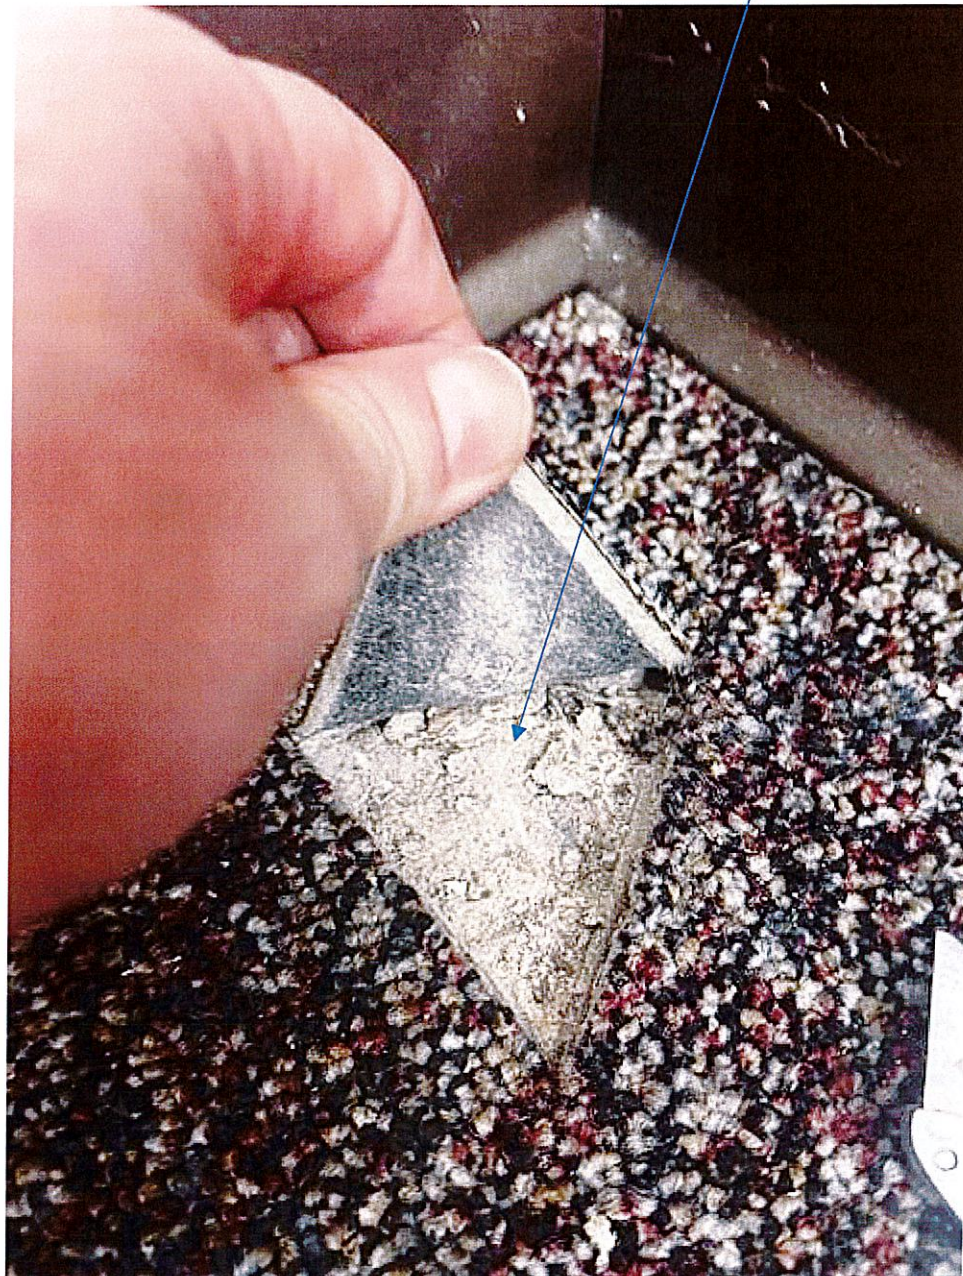
Room 240 – carpet mastic  
under carpet – non Acn

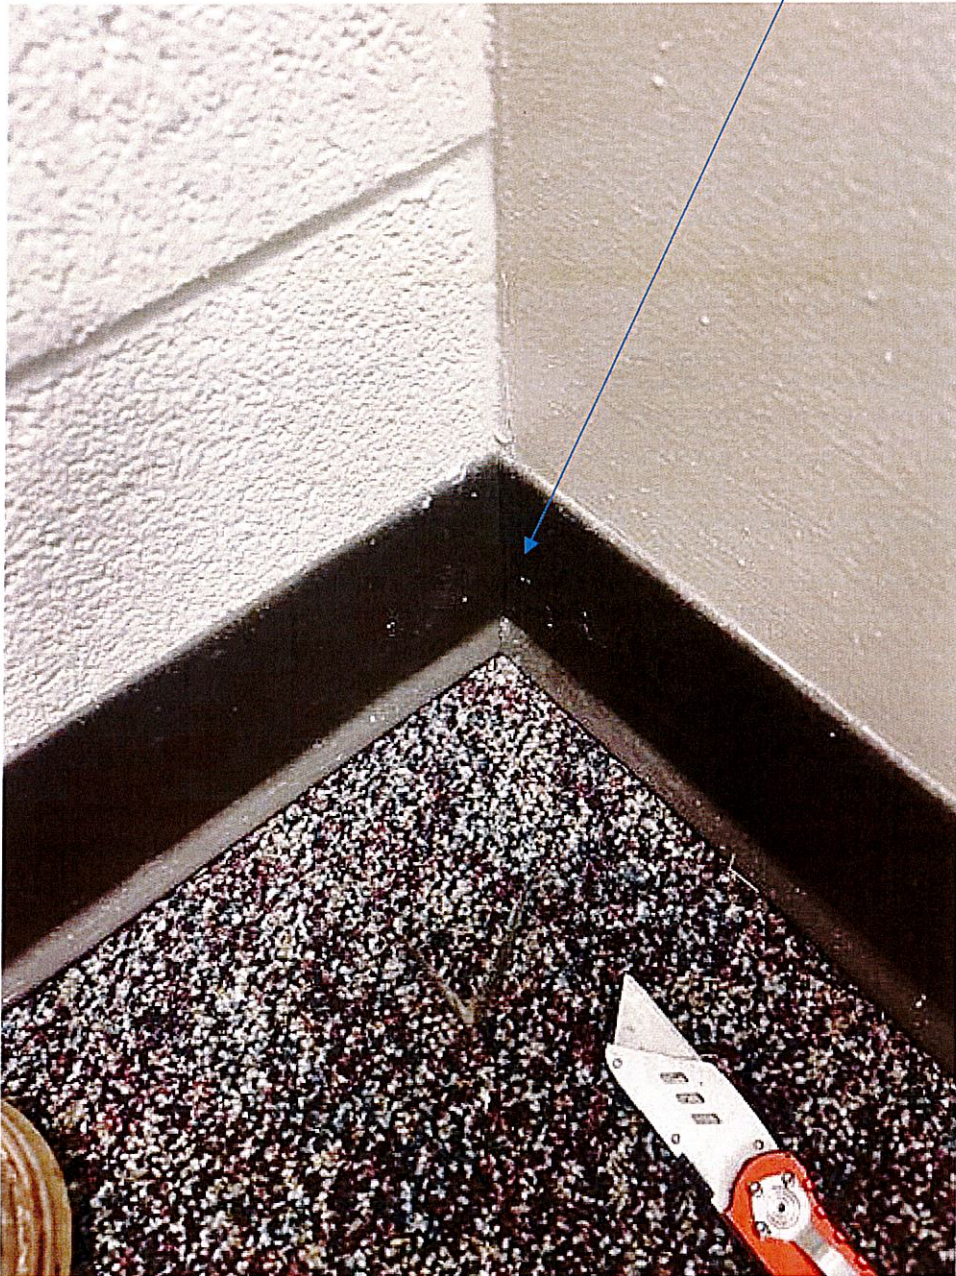
Rooms 232,234,236,238,240 –  
all brown cove base and  
adhesive is non ACM
